## SUPPLEMENTARY MATERIAL

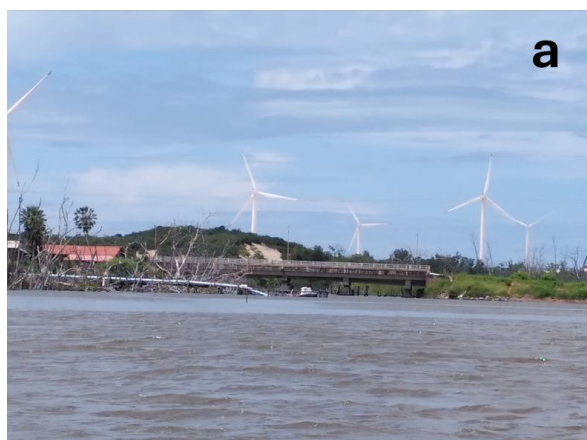
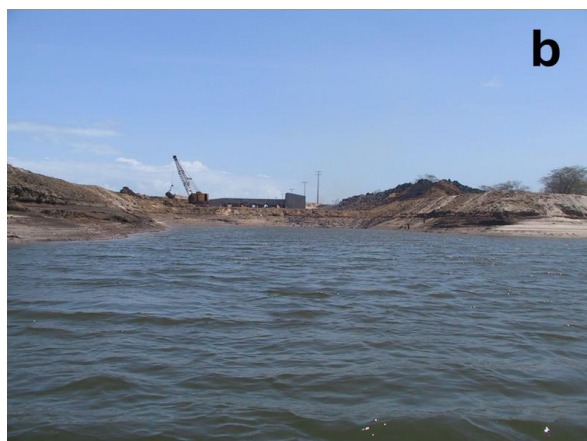
**Figure S3.** Engineering works (roads, bridges, electrification and housing) associated with the development of wind power fields. Dead mangroves bordering road and bridge crossing a tidal creek are visible (a). Water intake canal construction for aquaculture farms at the main Jaguaribe river. Note remaining mangrove trees to the right behind the dredged material deposition site (b).

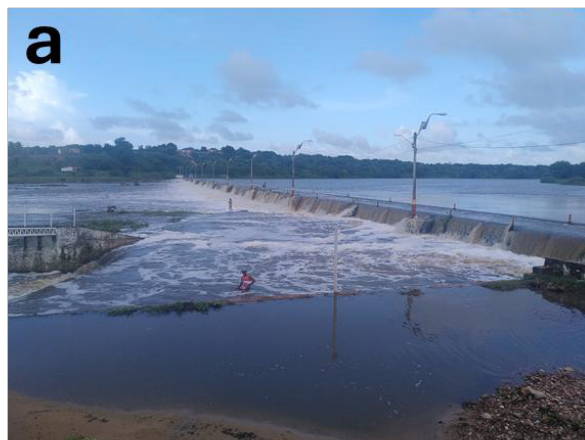
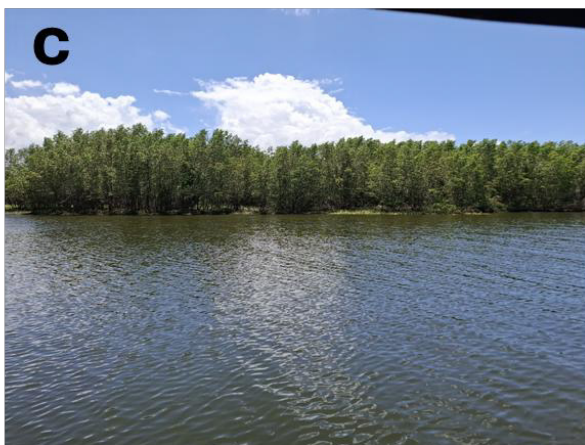
**Figure S4.** Dam crossing the Jaguaribe river at Itaiçaba village, in the upper estuarine basin causes sediment trapping due to reducing river flow (a). A fringe of *Laguncularia racemosa* colonizing recent enlarged river beaches (b) and newly formed river islands (c).
